MVU Tower Moisture Prevention Kit Installation

I n s t r u c t i o n S h e e t
PN 28-0787

This instruction sheet applies to Lancer PN 82-4168 (CCPN 122686).

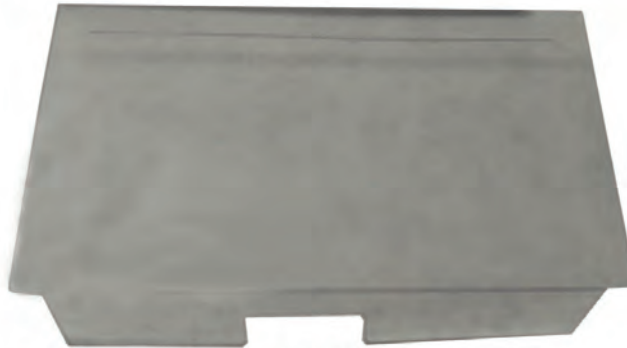
50-0586 Insulation Strip, MVU Tower

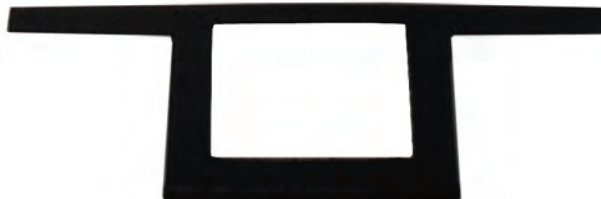
05-2832 MVU Control Board, CVR, Plastic

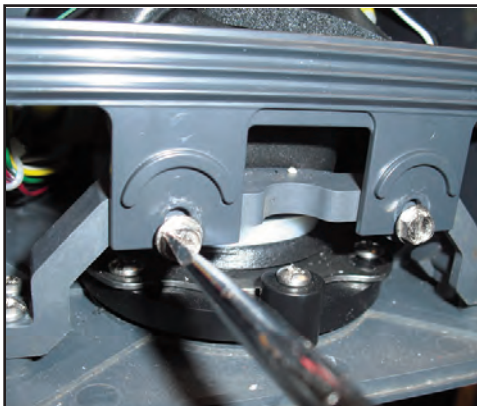
STEP 5

Loosen screws that secure cover so control board moves freely.

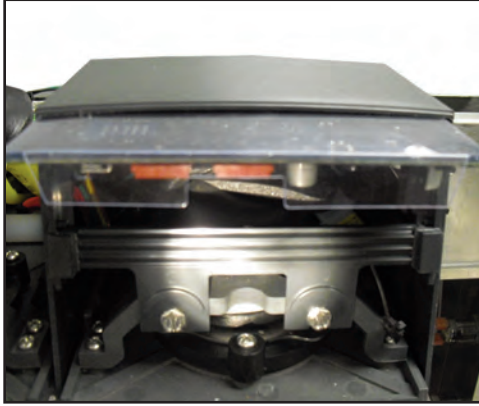
STEP 6

Pull control board out slightly (as shown) and slide CVR, Plastic (05-2832) between control board and cover. Push in control board and tighten screws.

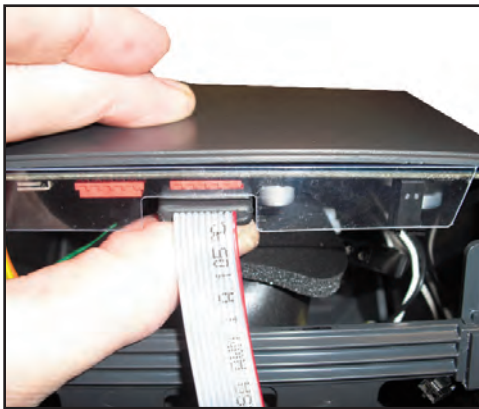
STEP 7

Attach connector of ribbon cable to control board as shown. Make sure red stripe is on the right side.

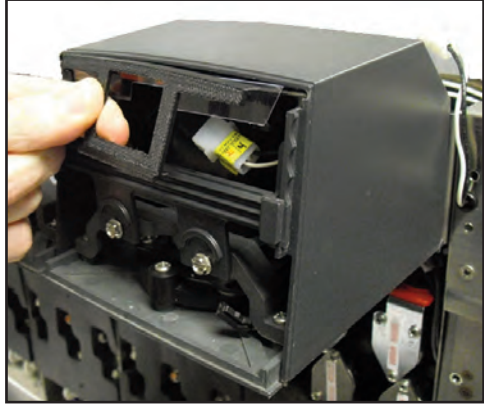
STEP 8

Insert plastic shield top first in between control board and cover.

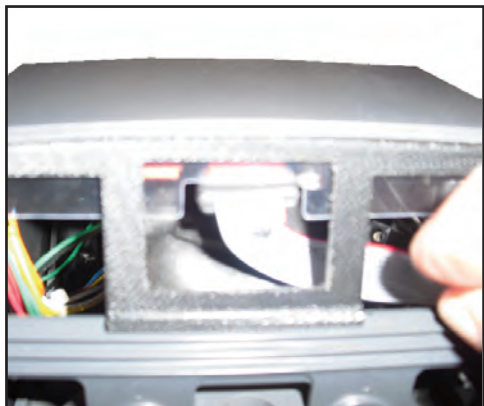
Shown: plastic shield insertion complete.

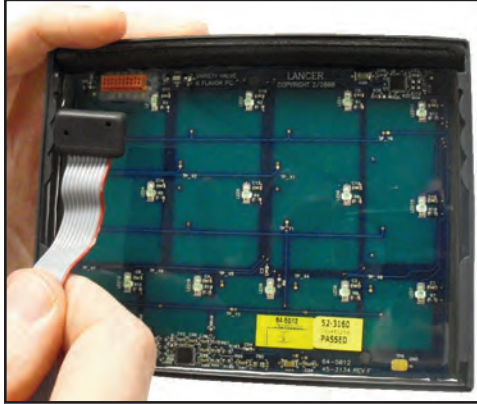
STEP 10

Attach opposite end of ribbon cable to button board front cover. Make sure red stripe is on right side.

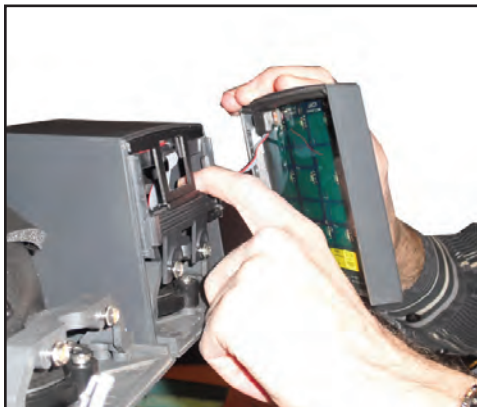
STEP 11

Route ribbon cable to the right window of the shield. Note that the ribbon cable must be placed behind the MVU cover cross bar. A ribbon cable that contacts the back side of the MVU ID panel (button board) may cause one or more of the selection buttons to malfunction.

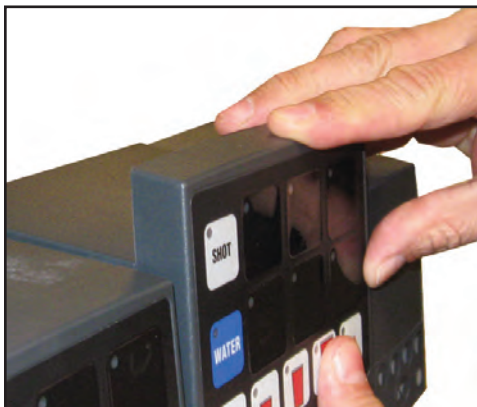
STEP 12

Slide MVU ID panel (button board) in place and ensure that ribbon cable is not in the way.
